FACILITY COMPLIANCE INSPECTION REPORT

Division of Waste Management Solid Waste Section

Date of Site Inspection: 8/13/2014

Grandfather Golf & Country Club Landfill, Newland
 Hickory Gap Road
 Newland, N.C.

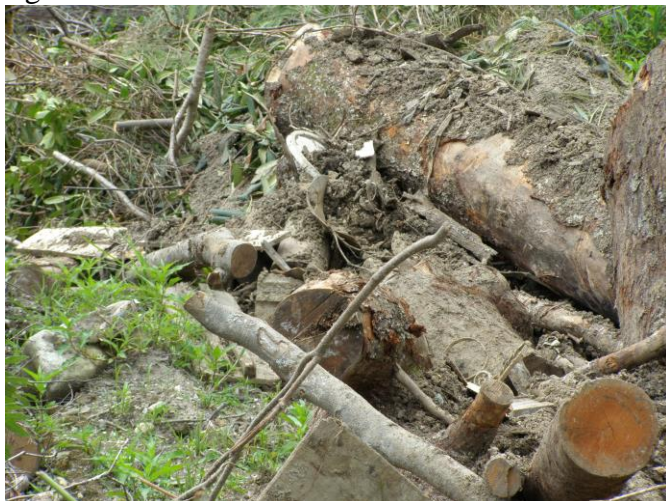
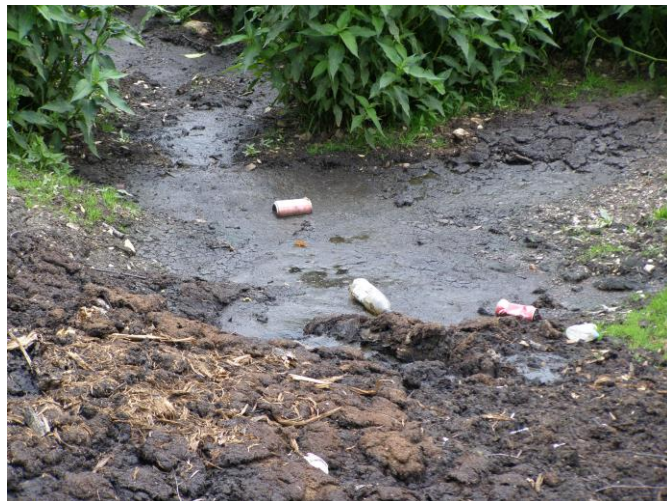
On August 13, 2014, the following unacceptable wastes were observed mixed in with two loads at the working face: a painted board, a plastic bucket lid, and several pieces of plywood; and plastic and aluminum beverage containers were observed mixed in with grass clippings. This is a violation of 15A NCAC 13B .0566(2). To achieve compliance, all unacceptable wastes must be removed for proper disposal.

Views of unacceptable wastes observed at the working face and in grass clippings.
Digital Photographs taken by D. Aja on 8/13/2014.
